# 2020 Legal Update Luncheon

**Decks: Destructive Testing, Why They Fail, Repairs & Reconstruction**

# **NEW DECK INSPECTION LAW**

# Elevated Elements: Mandatory Inspections

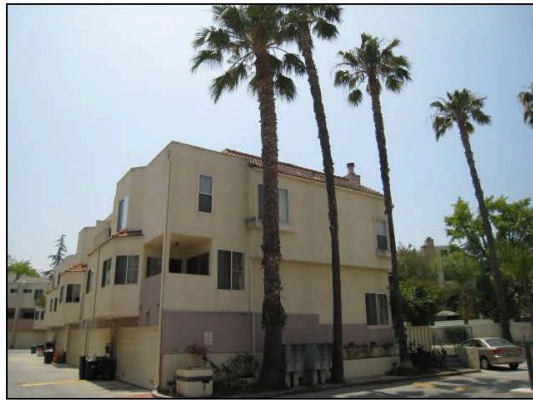
5551 does not apply.  
This corner balcony does not extend beyond the exterior walls of the building.

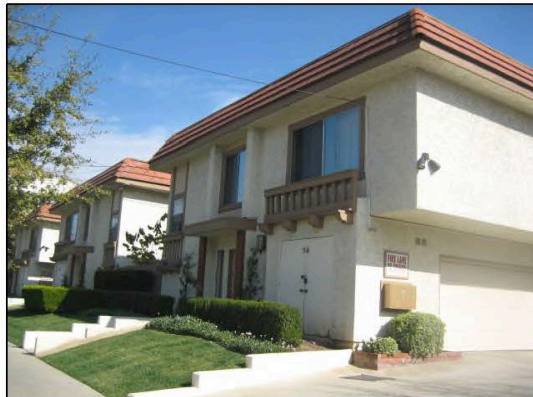
5551 does not apply.  
The "faux" balcony outside/below the window is not a structural element designed for human occupancy. It is trim. The roof over the doorway is a roof, not a structural element designed for human occupancy.

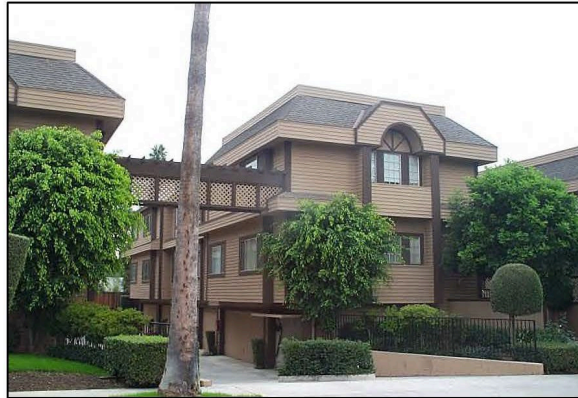
5551 does not apply.  
The decorative element  
between buildings, over  
the driveway, is not  
meant to support  
humans.

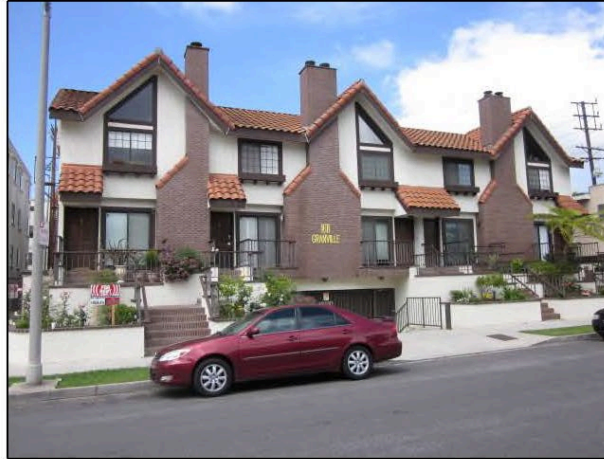
5551 likely applies.  
While the balcony may  
not be (exactly) in  
excess of 6' above  
ground, we wouldn't  
want a loved one with a  
small child to be on it  
when it fell.  
Recommendation: be  
generous in your  
application of the 6'  
above ground standard.

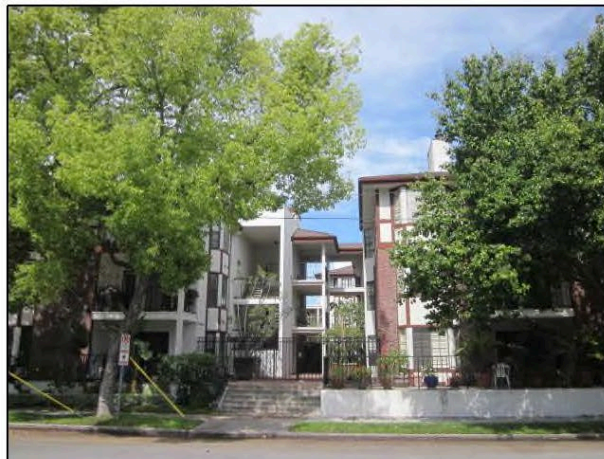
5551 likely applies. The stairwell area projects from the exterior wall of the building.

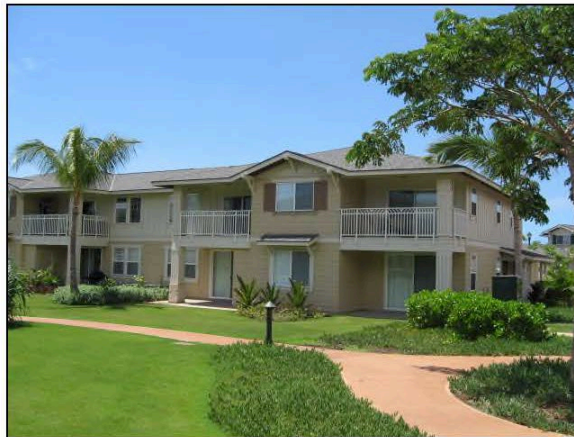
5551 likely applies. While the bulk of the balcony is within the exterior profile of the building, there is a projected portion and leaning against the railing is potentially hazardous.

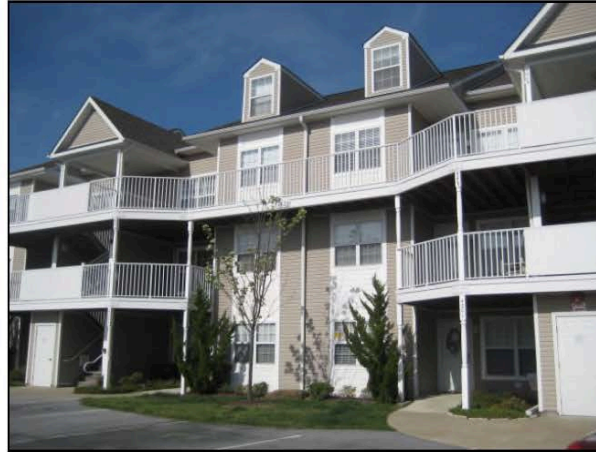
5551 likely applies. Balconies are supported by columns, and surfaces project from the exterior envelope of the building.

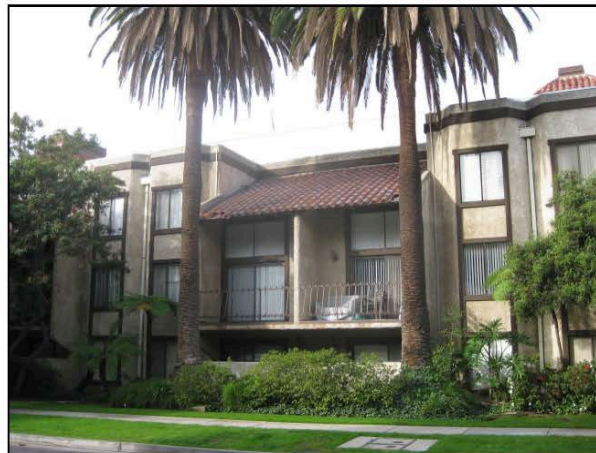
5551 likely applies. Marginally 6' above ground, but it presents potential danger/harm to anyone on it if it fell, or if they leaned against the railing.

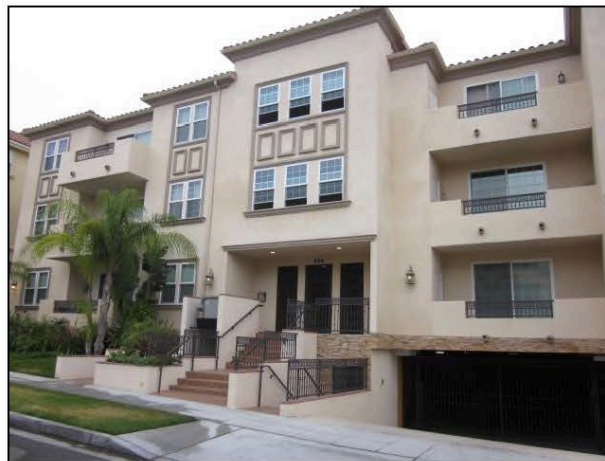
5551 does not apply. No wood or wood-based balconies on this high-rise (although it may be wise to recommend a safety inspection).

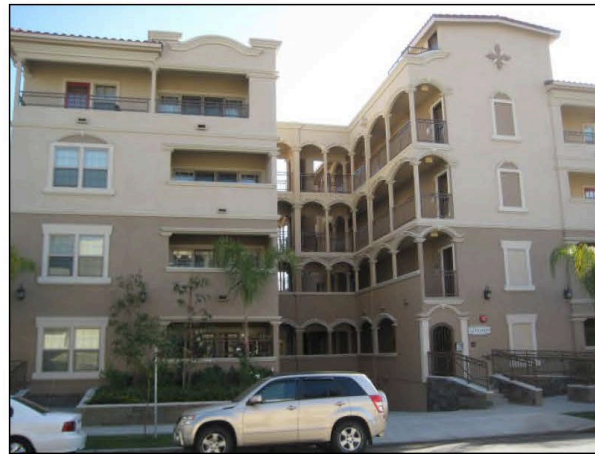
5551 likely applies. Elevated walkway areas designed for humans supported by columns. Note that balconies on left side of photo appear to be within envelope of building, thus not fall-able.

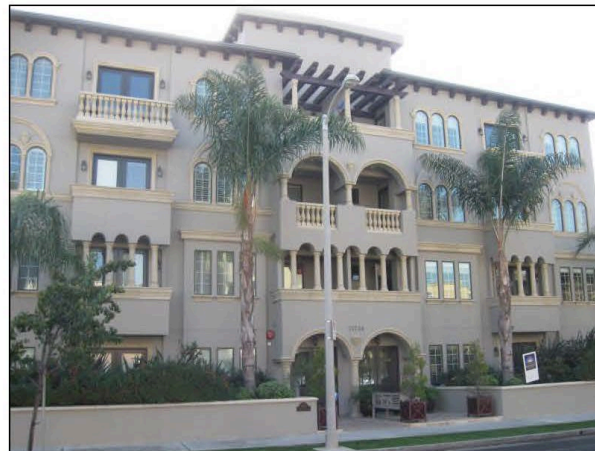
5551 likely applies. While balconies outside sliding doors may be very shallow, they project from building envelope and thus are fall-able.

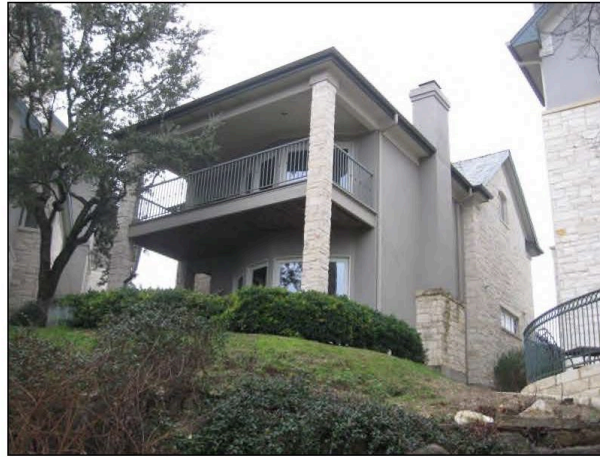
5551 likely applies. While under the roof line, this balcony projects from the building exterior surface and is supported by columns. Expect the rock on the column is just veneer over wood structure.

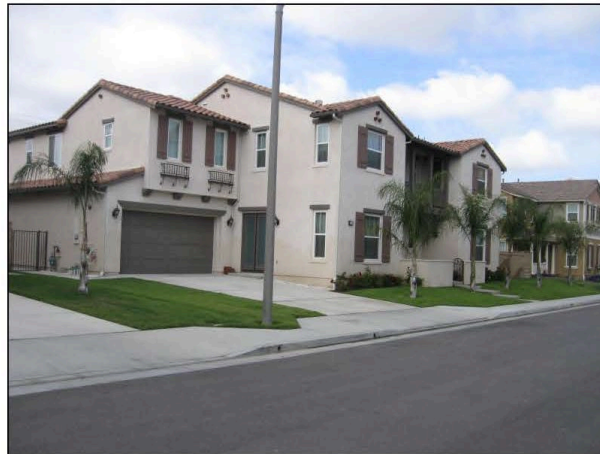
5551 does not apply (presuming this to be condo, and ignoring anything over front walkway entrance).

Ironwork below windows is just decorative trim, not a structural projection from the building exterior envelope designed to hold humans.

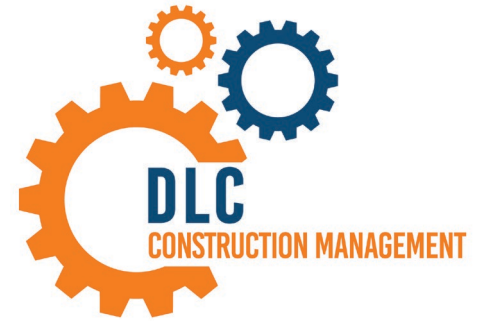
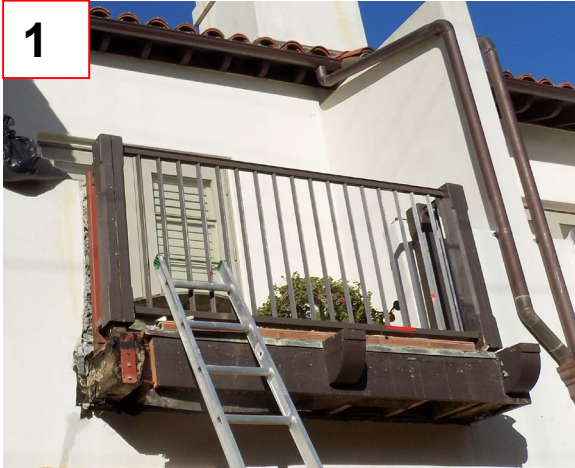
1. Cantilever Balcony
2. Elevated Walkway
3. Post and Beam Deck

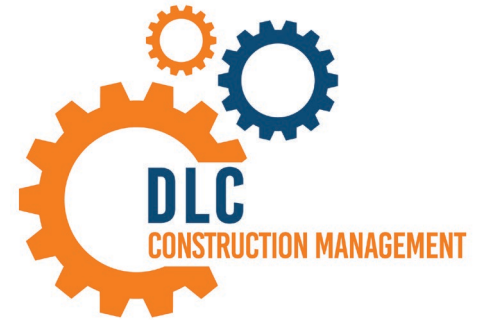
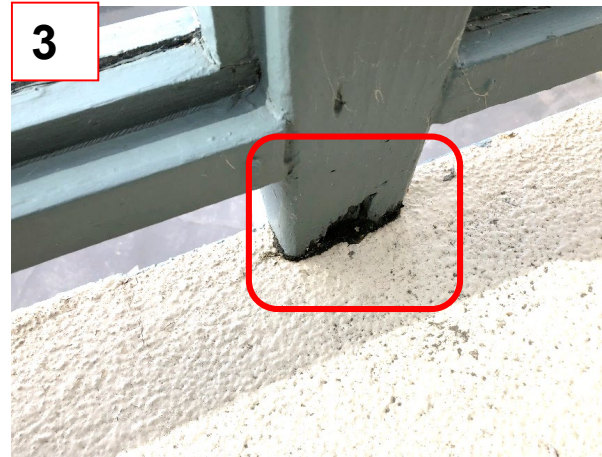
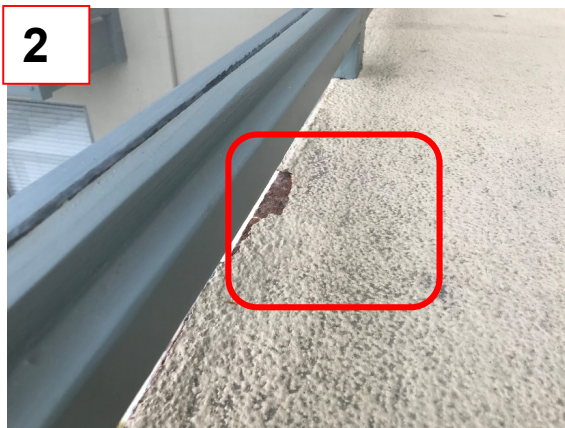
# SB-326: Flashing

1. Punctured Traffic Surface
2. Edge Metal Flashing Rusted
3. Penetration = No Flashing / Rotted Post

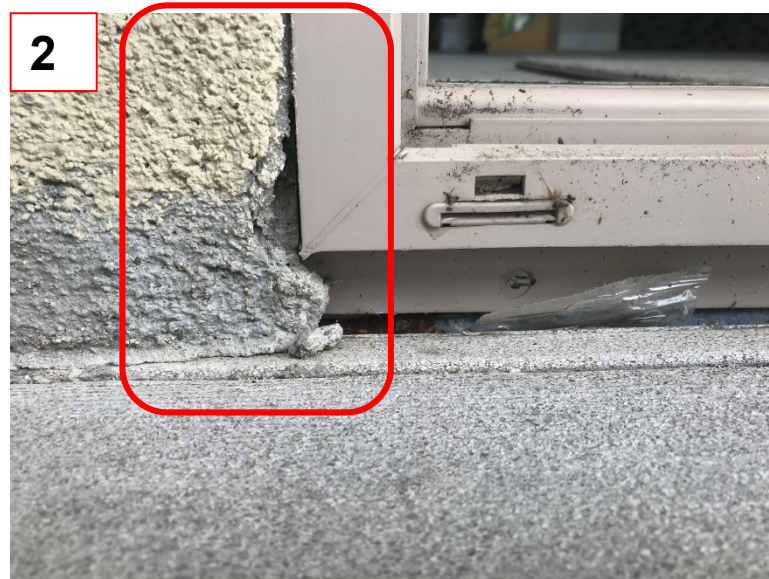
2

- 2. Sliding Glass Door:**
- No Door Pan Flashing
  - No Wall To Deck Separation

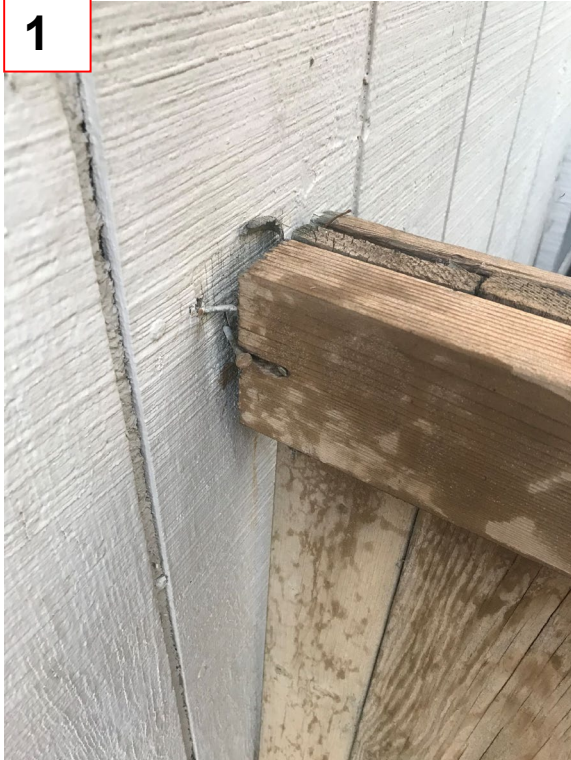
1

# SB-326: Railing

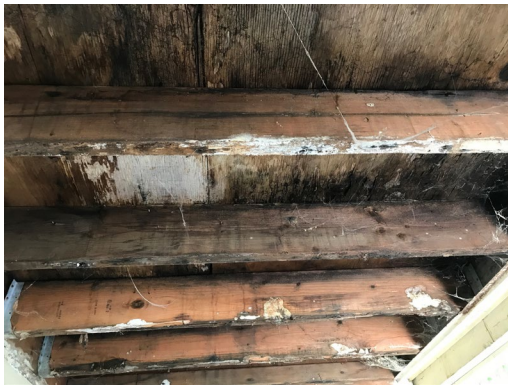
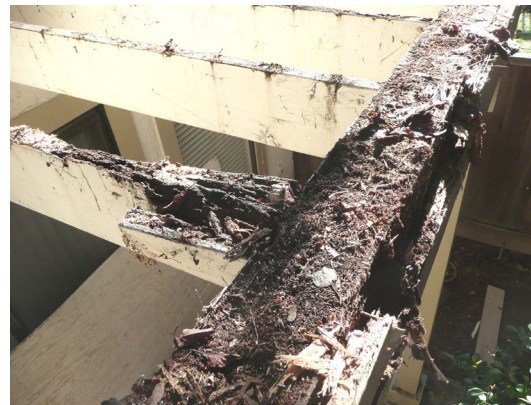
**Site Wide  
Inspection:**  
Building Siding,  
Trim, and  
Balconies/Decks

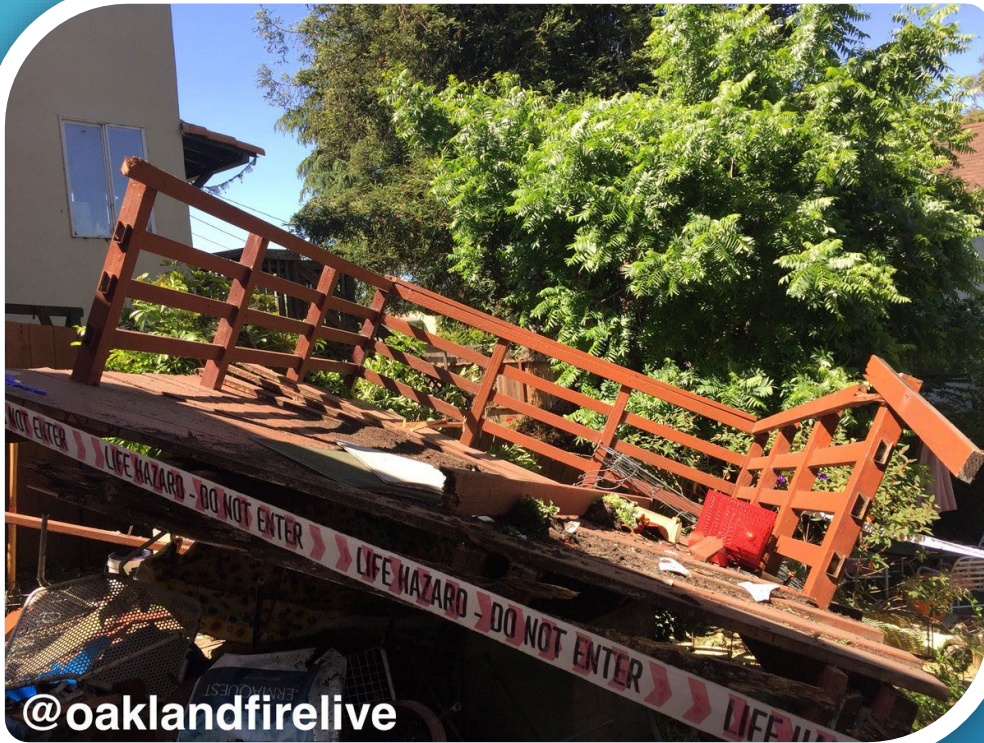
- **3400 Morcom Ave, Oakland**
- **Community was Built 1980's**
- **Post and Ledger Framing**

*3 people were injured when this deck collapsed in May of 2018.*

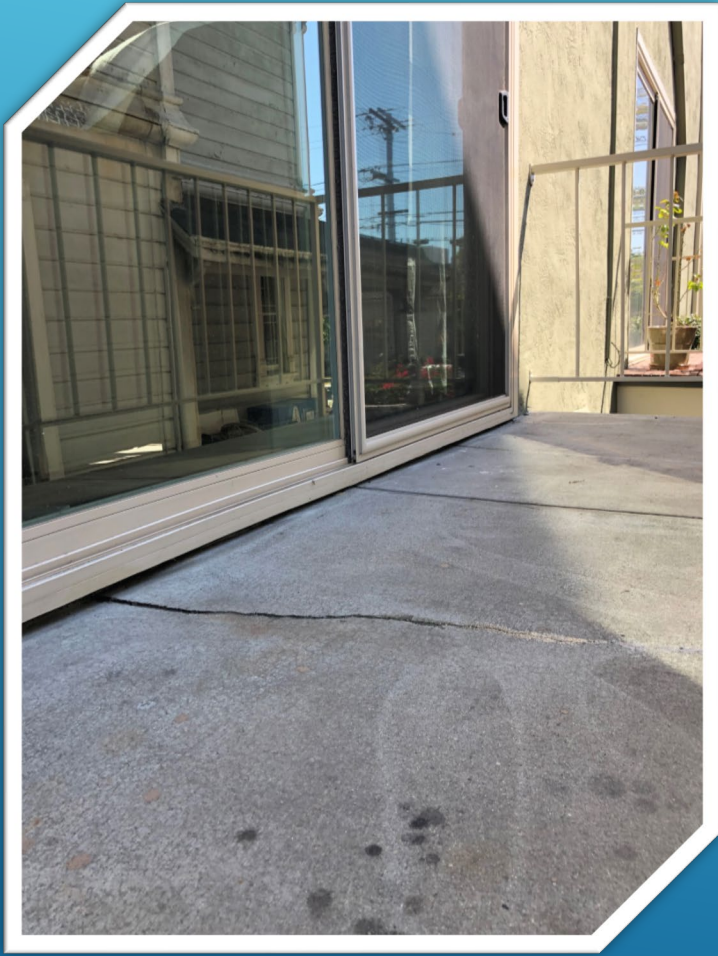
# Alameda, CA

**As Universe Painting and Construction was preparing to paint this community last summer, our crew noticed cracks in topping slab on a deck.**

**Minor dry rot  
was noticed on fascia.**

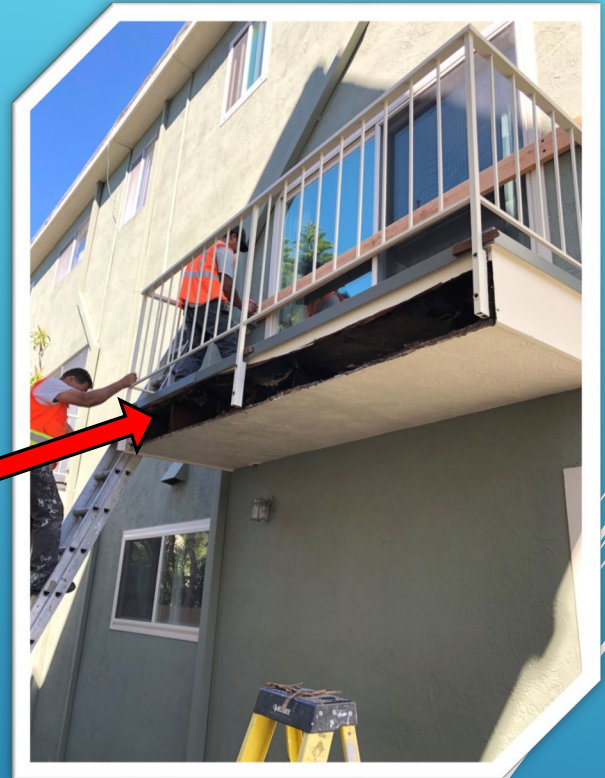
**What is missing from the  
deck in the photograph ?**

**There should be joists  
there.**

**Destructive testing and regular deck inspections  
Could have caught this before it became a life safety hazard**

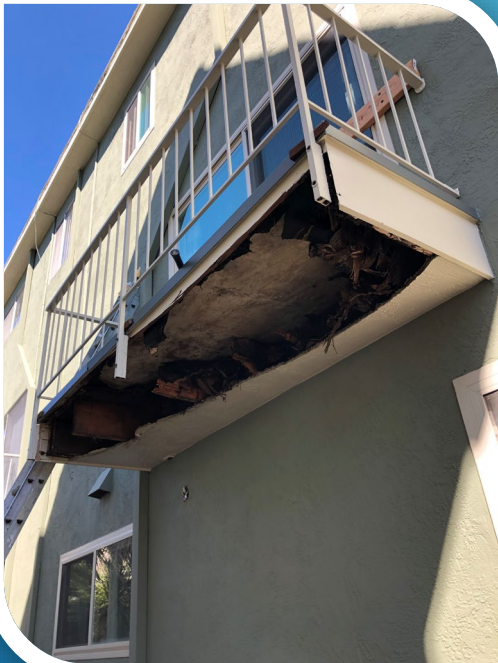
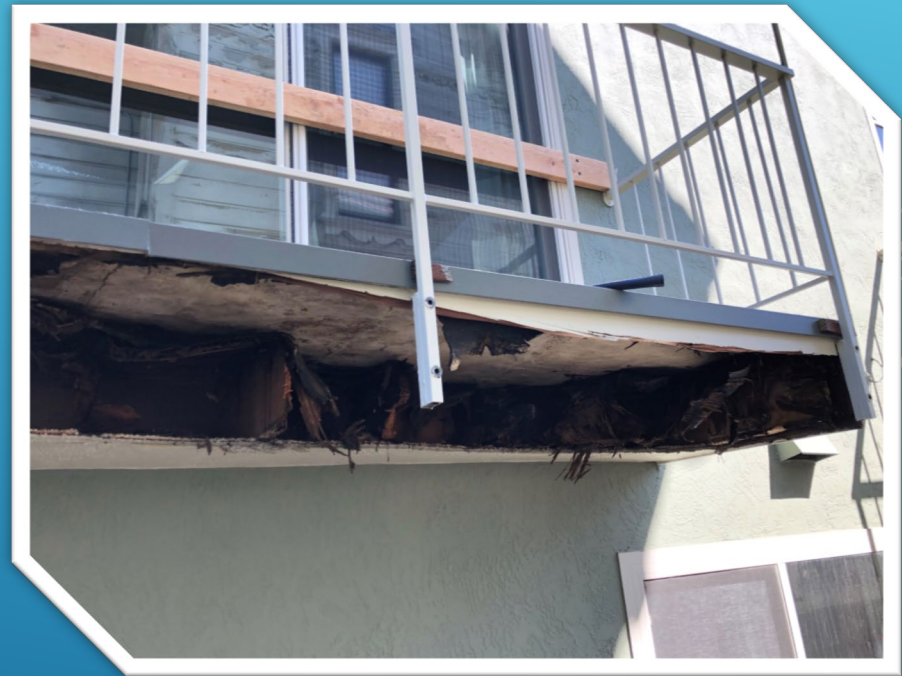
# Upon Further Inspection

**80% loss of  
cantilever  
joists**

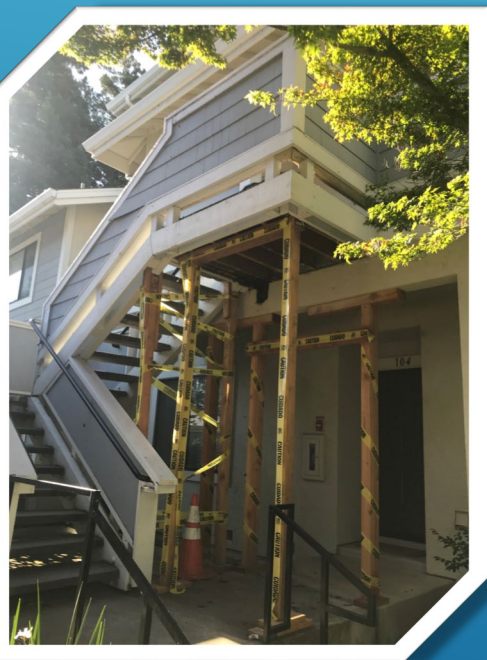
- **Stairwells**
- **Elevated walkways**
- **Landings**

**Elevated walkways are susceptible to the same failures as decks**

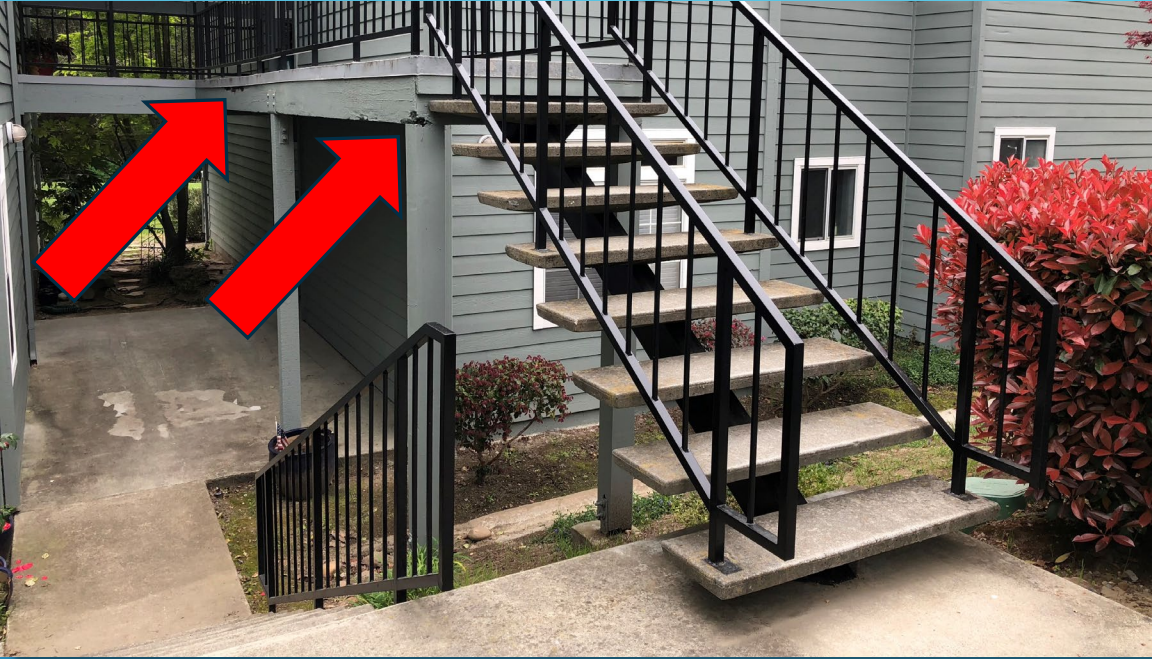
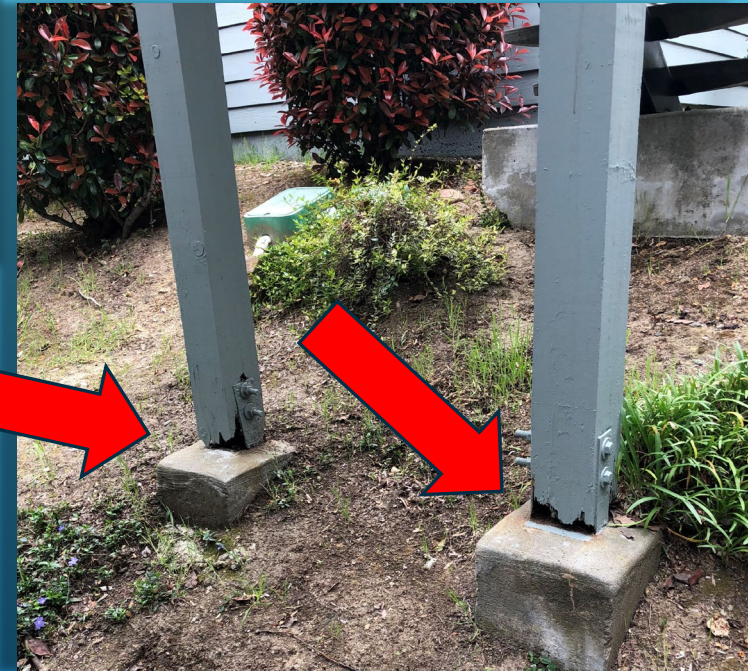
## **Elevated Walkways and Support Posts**

**Wood posts are susceptible to deterioration at both the base and the top.**
